Electrochemical Corrosion Failure Analysis of Large Complex Engineering Structures by using μ LPR Sensors

Abstract

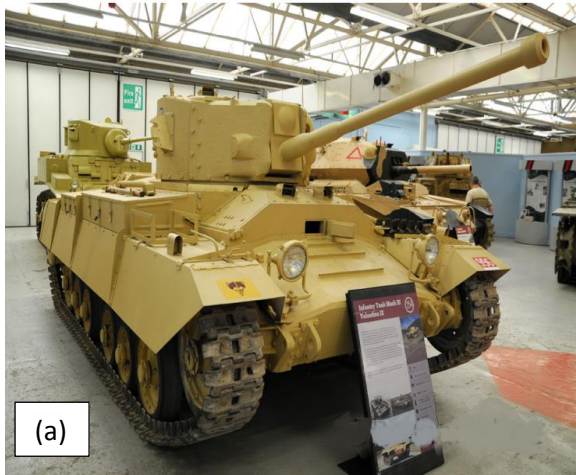
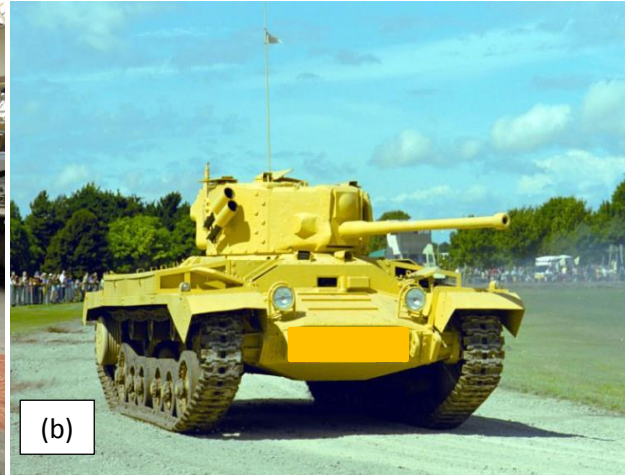
Figure 3. (a) A stationary large vehicle (preserved) from the stationary set (b) An operating large vehicle from the operating set (c) Location of the Tank Museum [43]

Two set of vehicles were used for experimental analysis, stationary set (fig. 3 (a)) and an operating set (fig. 3 (b)) at the Tank museum. Operating set included a group of two vehicles in constant operation under uncontrolled environmental conditions while stationary set included another group of two vehicles permanently preserved inside the Tank Museum under controlled conditions. The two operating vehicles were operated at the same time and under the same uncontrolled environmental conditions. The reason for setting two vehicles in each set (operating and stationary) was to ensure the repeatability. A three years study (Aug. 2013 to Aug. 2016) was performed on these two set of vehicles. The study included the collection of data from μ LPR sensors, taken from both stationary and operating set. The operating set was used 8 times (known as operations A, B, C, D, E, F, G and H) in round trips (in-and-out) during three years. While the stationary set was preserved inside the museum. All eight operations were performed during the summer time in April, May and June of every year in sequence mentioned in Table 1. Operation A was performed in April 2014, operation B was performed in May 2014. Similarly at the end of study, operation H was performed in May 2016.

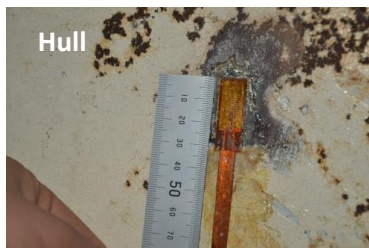
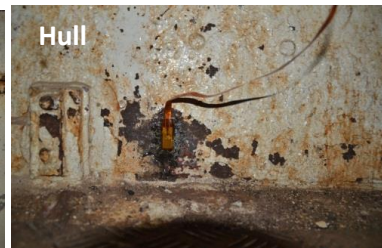
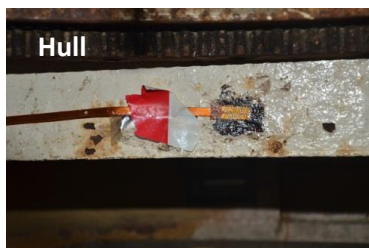
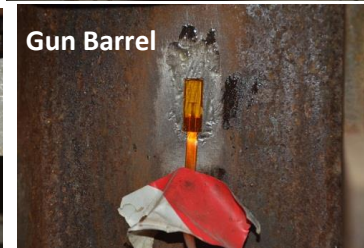
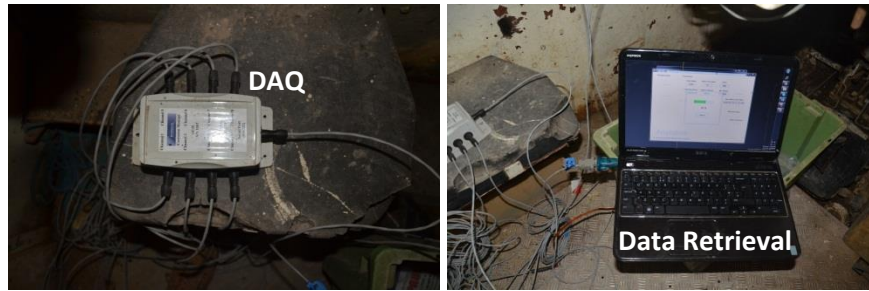
Figure 4. μ LPR sensors installed at various locations inside the tank. The last two images show the data acquisition unit (left) and PC connected to data acquisition unit to retrieve the data.

The eight sensors were installed on exposed metal parts of vehicles i.e. bare steel. Six inside sensors, including μ LPR3 and μ LPR 4 were installed on uncoated parts of the gun barrel while other sensors μ LPR5, μ LPR6, μ LPR, 7 and μ LPR8 were installed on inner vertical walls of hull where coating has already delaminated due to corrosion, as can be seen in fig. 5. Similarly two outside sensors μ LPR1 and μ LPR2 were installed on delaminated area of turret top. Before installing sensors, the steel surface was pre-treated with the solution of 50 g/L Turco 4215 NC-LT in order to remove any pre-existing contaminants. After cleaning, each sensor was installed.
